# The Historic Dimension Series

A student publication series by the UNCG Department of Interior Architecture

## Carpenter Gothic Architecture: Its History, Care, and Repair

by Katherine Crickmore

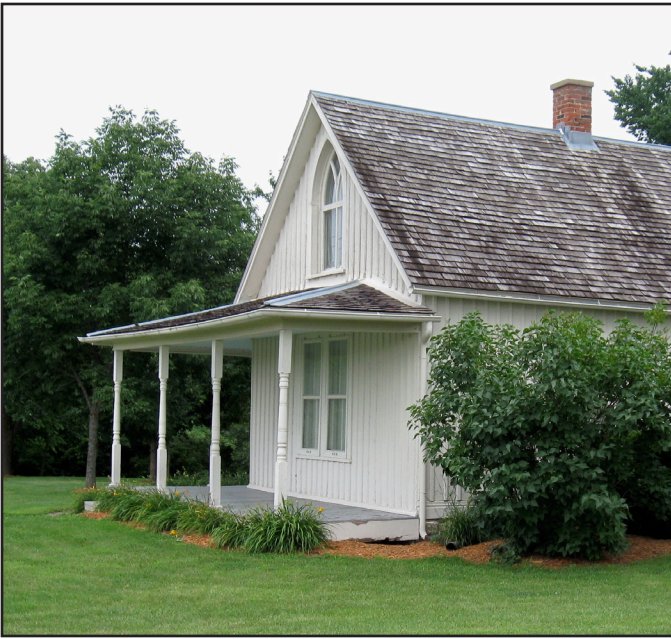
Figure 2: The inspiration for Grant Wood's famous *American Gothic*, the Dibble House in Iowa shows fairly simple, but still distinct, Carpenter Gothic design elements. Take note of the iconic front window. Eldon, IA.

ously appear both gracefully humble and delightfully over the top. The architectural style, also referred to as Rural Gothic or Gothic Cottage, was popular in the United States during the mid to late 1800s and was taken and adapted by all class levels. In fact, the Dibble House in Eldon, Iowa, which served as the inspiration for the classic *American Gothic* painting by Grant Wood and is still remembered as an iconic example of the style, happens to be a fairly simple Carpenter Gothic farmhouse.

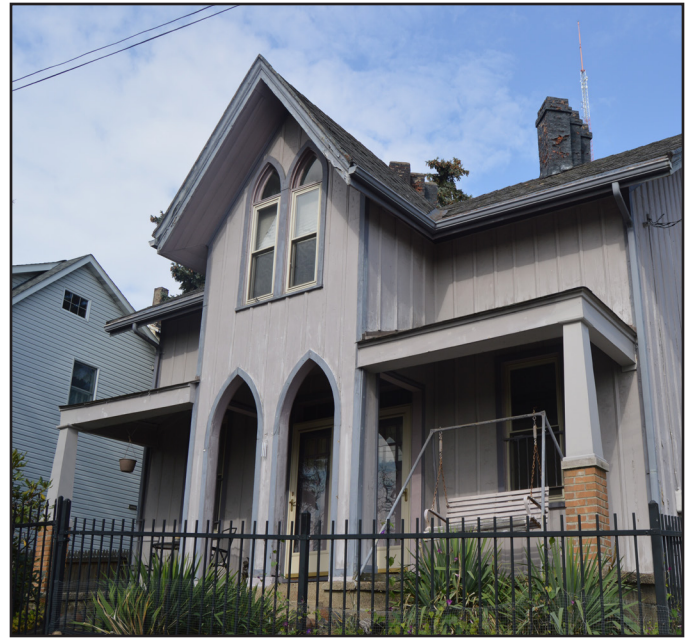
Figure 3: Compare the Dibble House with this Carpenter Gothic House in Pittsburgh. The distinct architectural features reflect a high style design that, compared to other modest examples, emphasizes the flexibility and creativity of Carpenter Gothic cottages. Pittsburgh, PA.

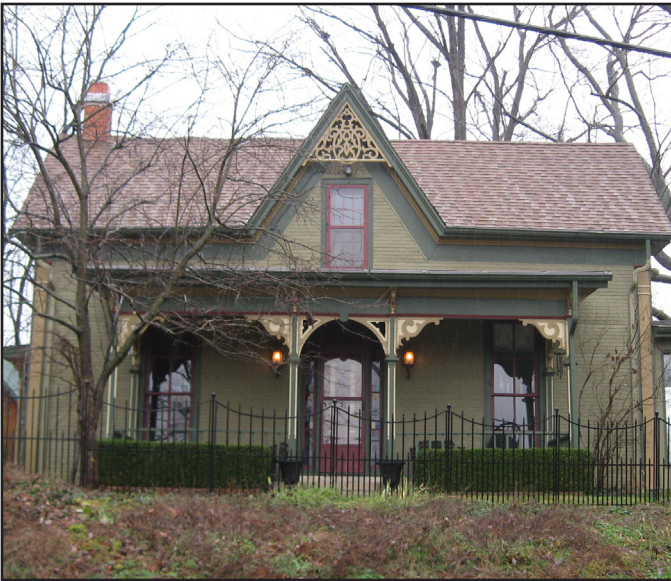
*Figure 4: The intricate scroll work and other wooden details seen on the house above are characteristic of the Carpenter Gothic style. Harrodsburg, IN.*

Intricately carved exterior trim, like spandrels, vergeboards, finials, and lattices, helped Carpenter Gothic houses achieve their hallmark storybook look. The use of wood allowed for endless variety and creativity through hand-carving or scroll saw work. Downing emphasized that ornamentation on the entrance door, principal windows, gables, and chimneys were required to best pull off the Carpenter Gothic design. Occasionally, cast iron would be used for this trim work, instead of wood, as it was considered more durable in humid climates and easier to mold in the absence of accomplished wood workers. This trim and ornamentation often incorporated Gothic design motifs like the trefoil, quatrefoil, and cinquefoil.

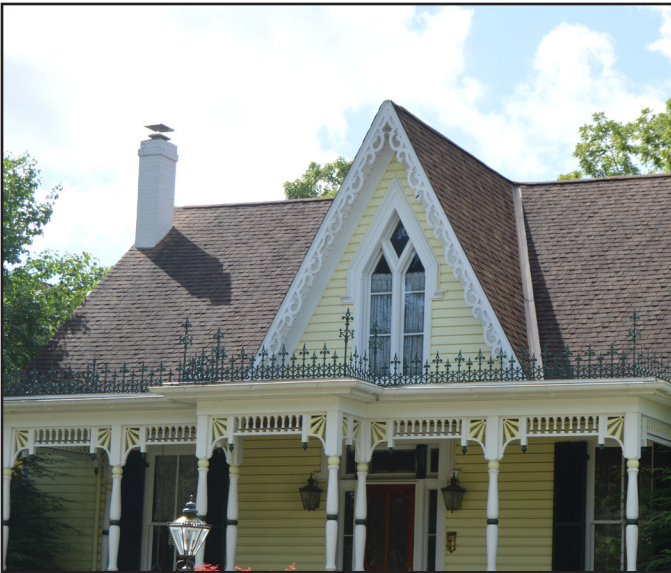
*Figure 6: Take note of the use of cast iron in combination with wood to create the classic Carpenter Gothic details on this Ohio cottage. Bellefontaine, OH.*

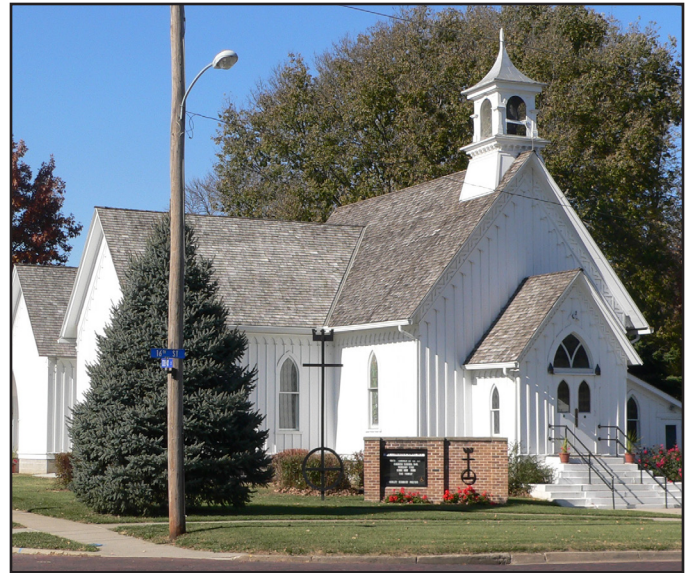
*Figure 7: The windows, clapboard, and trim on this rural church are distinguishing features of Carpenter Gothic architecture. Nebraska Congregational Church. Blair, NE.*

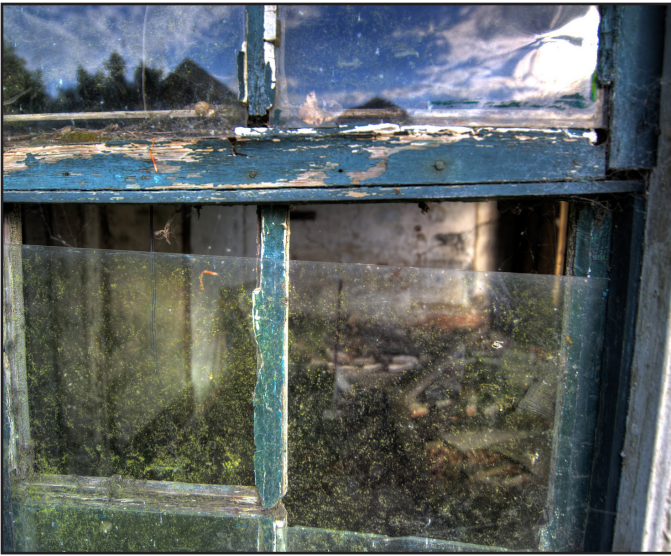
Figure 8: Though possibly not as severe as the window of this vacant house, lack of routine care can allow for moisture to penetrate wooden architectural details and cause extensive damage.

tural details, without needing to replace the entire feature. Keep in mind that windows and doors may have more significant operational issues due to frequent use and may require more specialized repair or replacement. If it is a question of repair or replace, it is usually a good idea to save as much of the original as possible, especially when it comes to the unique features of Carpenter Gothic cottages.

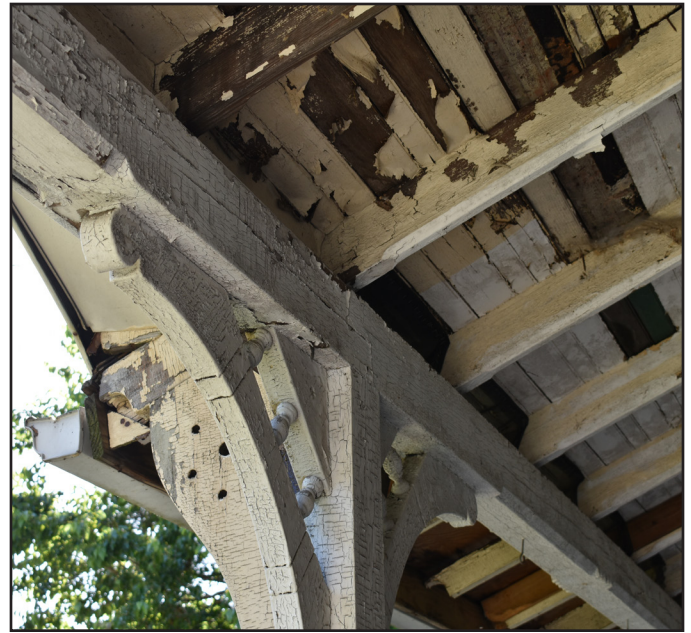
Figure 9: Cracking and flaking paint, like the paint seen on this porch, can expose wooden detailing to moisture and dirt, promoting further damage. Be sure to monitor the condition of the paint on Carpenter Gothic features and clean regularly.

As stated previously, some issues can easily be addressed by laymen, but others may require expert assistance. Flaking or weathered paint can potentially be hand sanded and reapplied, but take caution if the damaged paint is older, as it may contain lead. When sanding off paint, it would also be prudent to fully assess the wood beneath for additional issues.
